CAISTAEL TIORAM - UPDATE

CONDITION 23rd JULY 2014

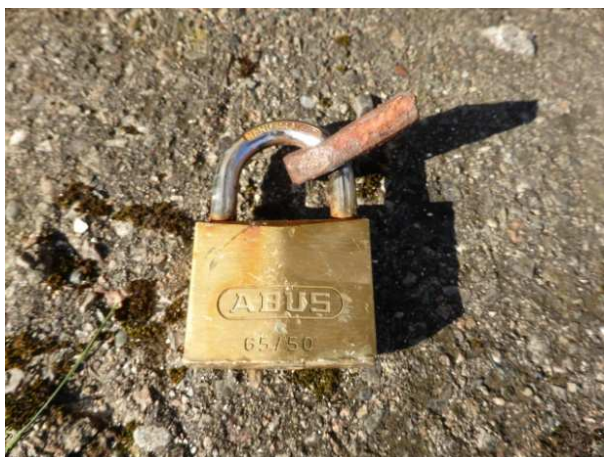
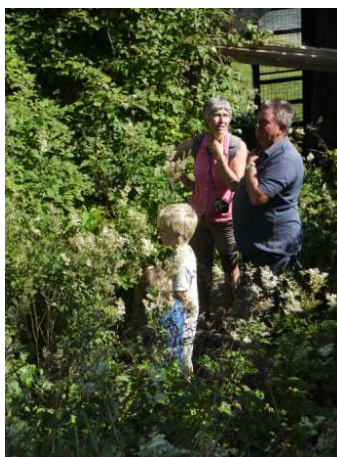
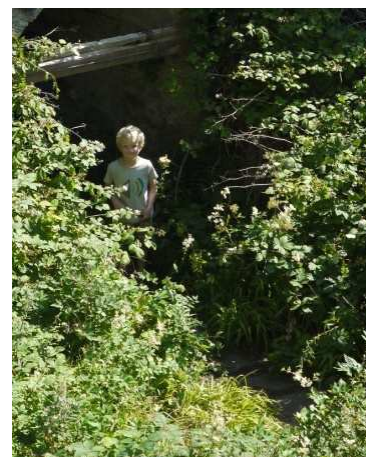
PUBLIC ACCESS

Since the gate was last inspected by us (May 2013) the padlock and its hasp has been broken off and laid aside. Paths have been made by people following natural desire lines to the Keep and South Range. We cut down some of the worst bramble. During the time we were there, from dawn till mid-afternoon, the castle was visited and enjoyed by a retired architect, a couple and a family from New Zealand.

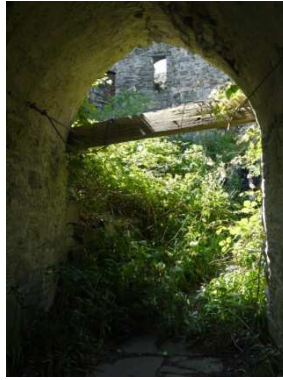
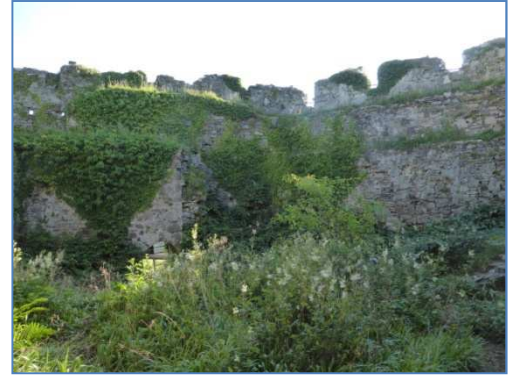
ENTRANCE

A decaying steel frame holding the door is kept in place by wire rope attached to a beam placed at a dangerously low height on the inner face of the wall.

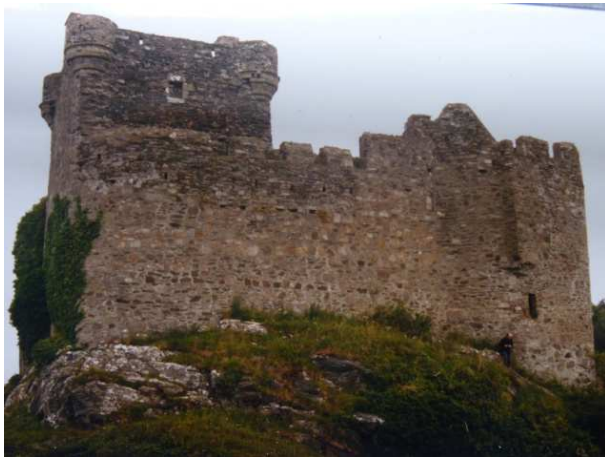
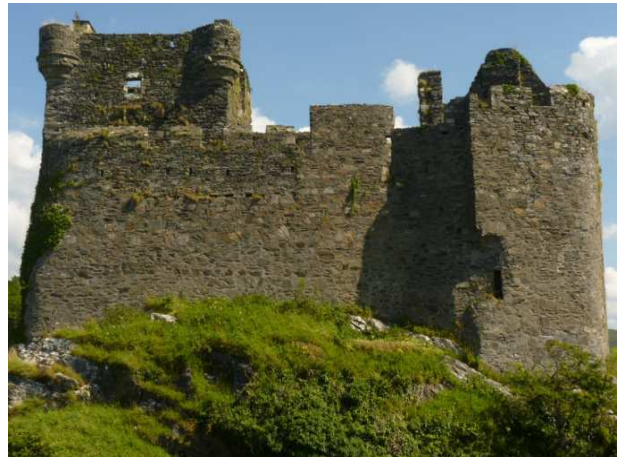
Externally and internally, the ivy that was incipient in several places in 1997 has all grown, as might be expected, and we removed as much as we could in the time available. There has been a modest increase in grasses and spleenwort ferns, indicating damp or perhaps the time of year. The holly tree growing by the fireplace in the room above the Hall has grown but remains much as it was before. Not a single stone in the breach of the barmkin wall, on the NW side, has fallen or moved for more than 30 years, despite the ineffectiveness of the propping - see Safety, below.

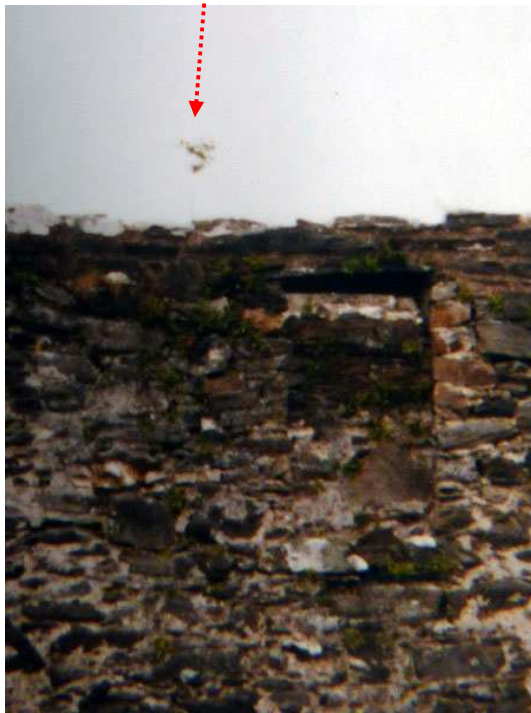
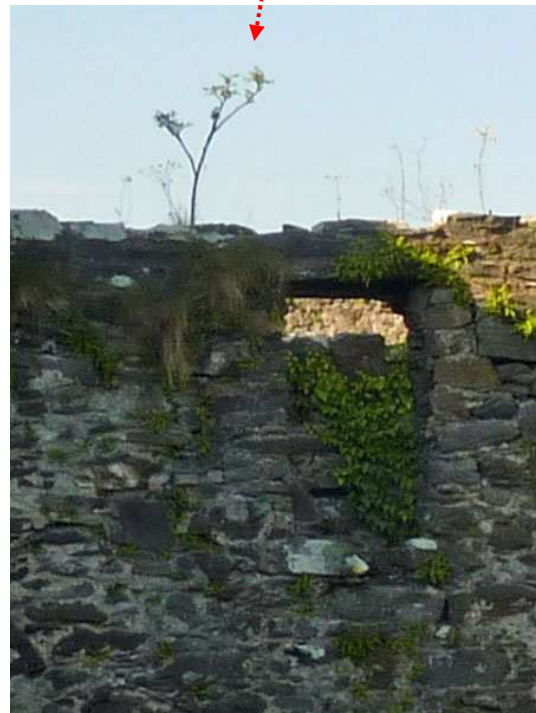
Rowan tree growing on the wallhead of SW Range, showing almost no change since 1997.

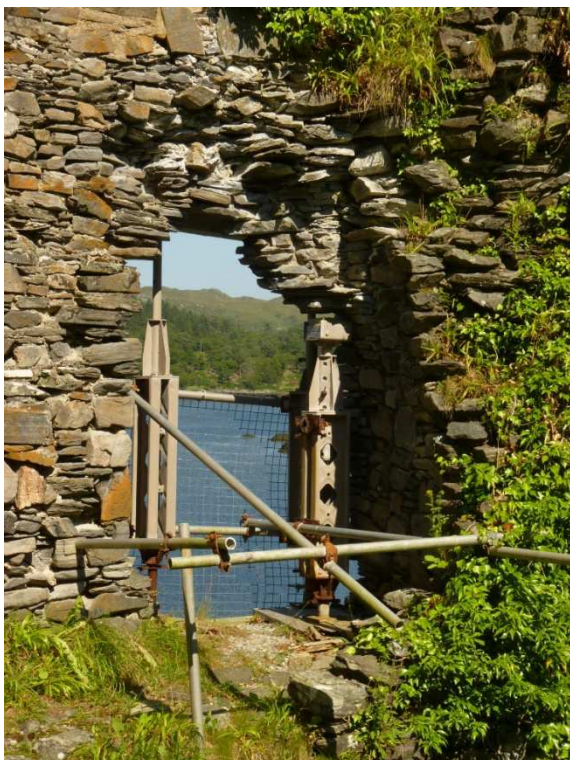
2014, showing no change to a single stone since 1984

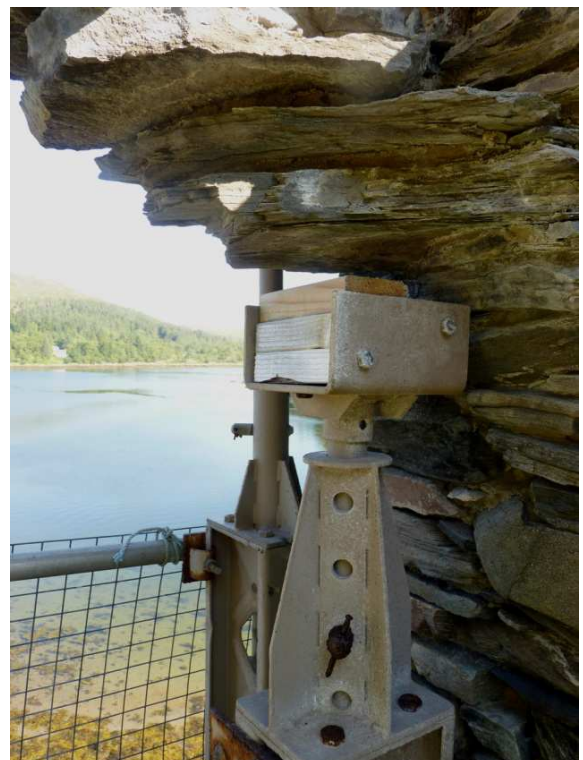
2014, detail, showing failed loose propping & missing packing etc.

Externally the warning signs have been largely removed and by the entrance the steel mesh fencing is falling over. The site was littered with abandoned and broken safety helmets. The propping of the breach in NW was entirely loose, with missing packers and wedges. The steel mesh are rusting away and the scaffold bracing is largely redundant. The old steel angle-iron bars in the battlements are still in place.

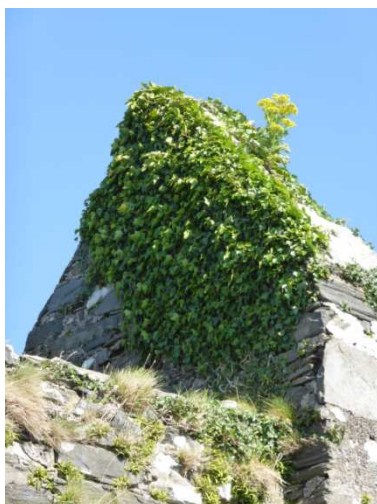
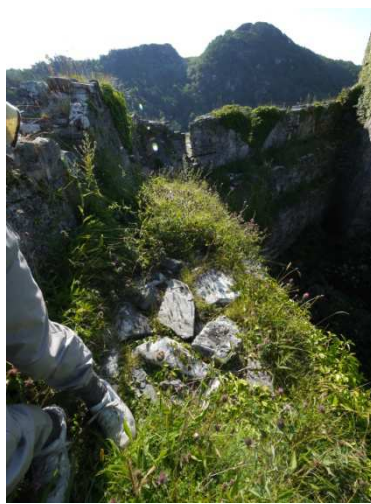
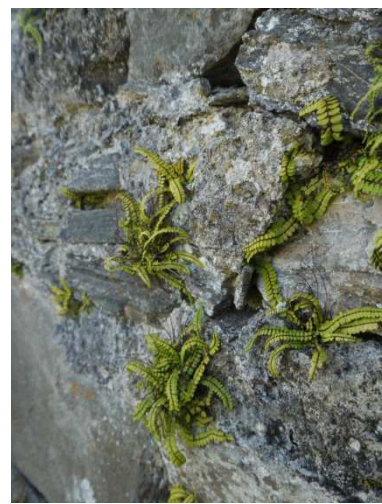
SKEWS & CHIMNEYS

All considerable amount of grass, ivy, herbaceous plants and ferns is growing on the gable wallheads.
