CAISTEAL TIORAM - a case of serious neglect

Denis Mollison, Caisteal Tioram Trust, April 2016

Interventions at Caisteal Tioram since 1998

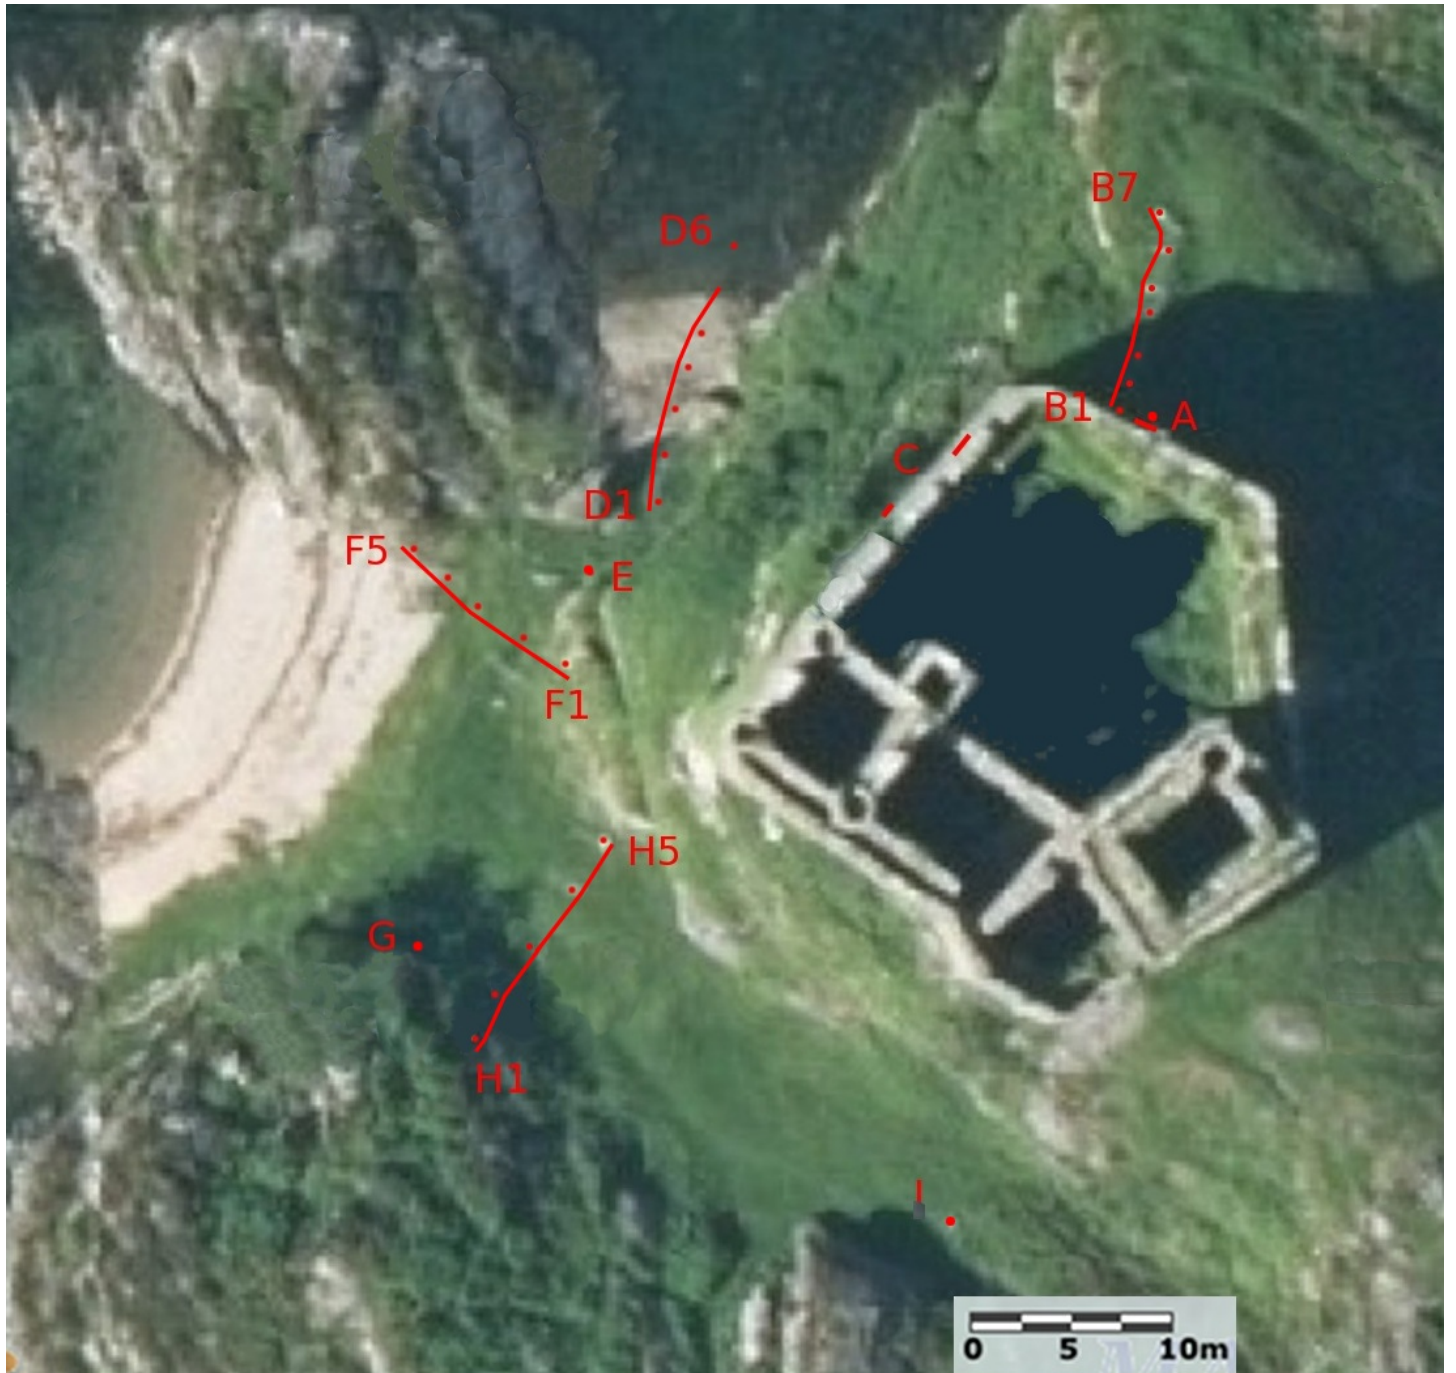
Location of interventions at Caisteal Tioram since 1998

The locations of A–I are shown on the aerial photo map on the page opposite. Photos of all except J and L appear on the following pages.

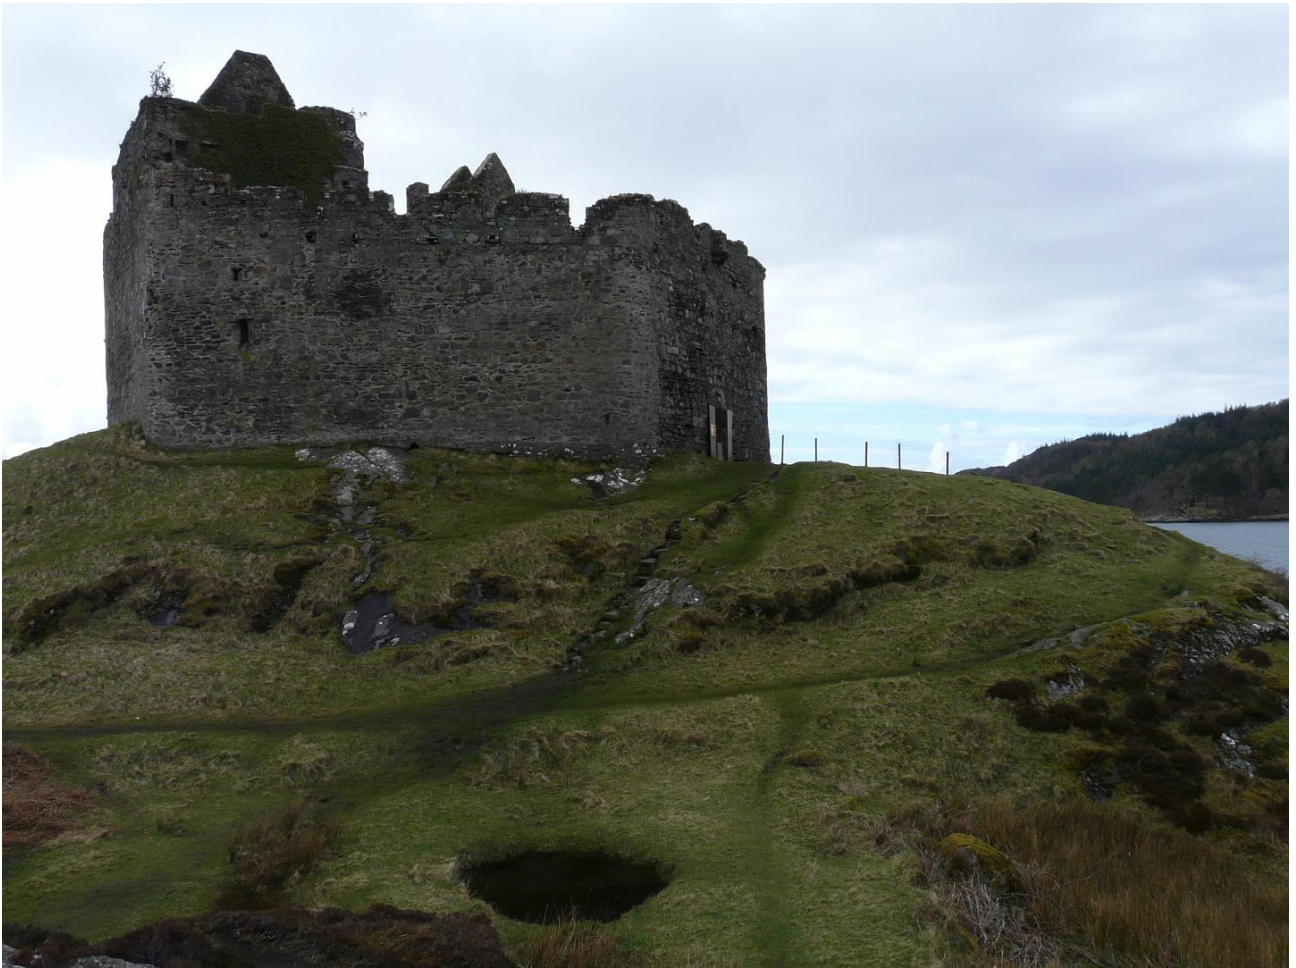
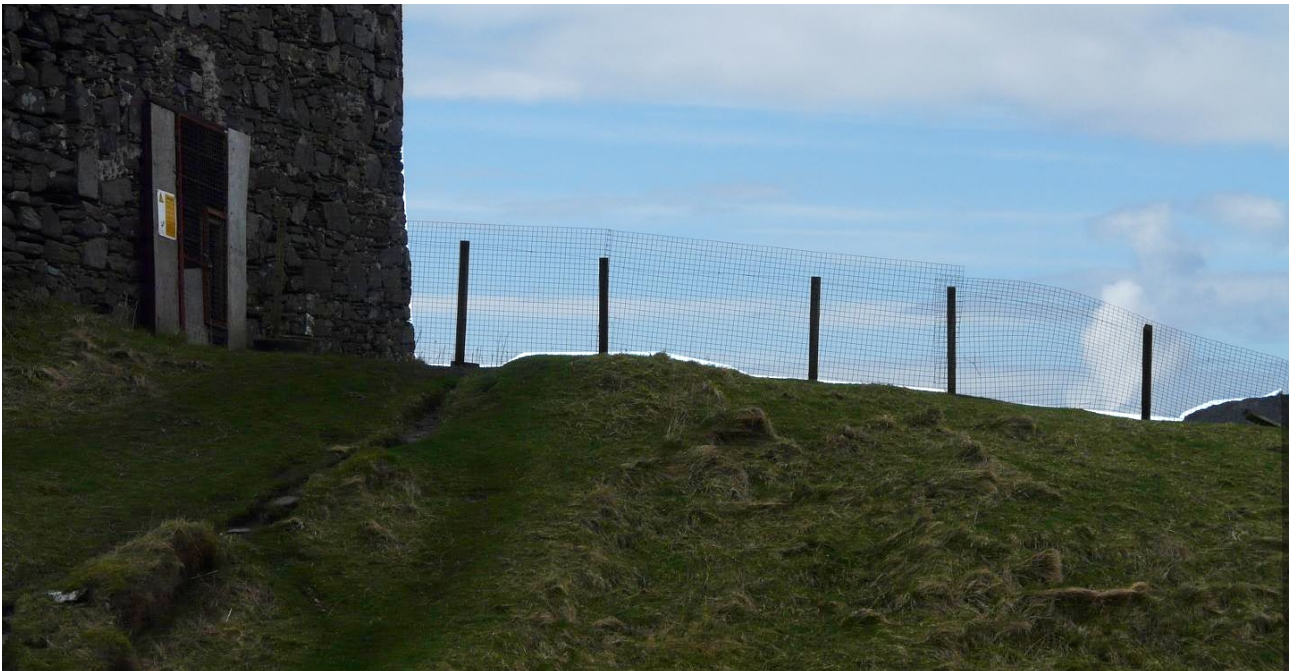
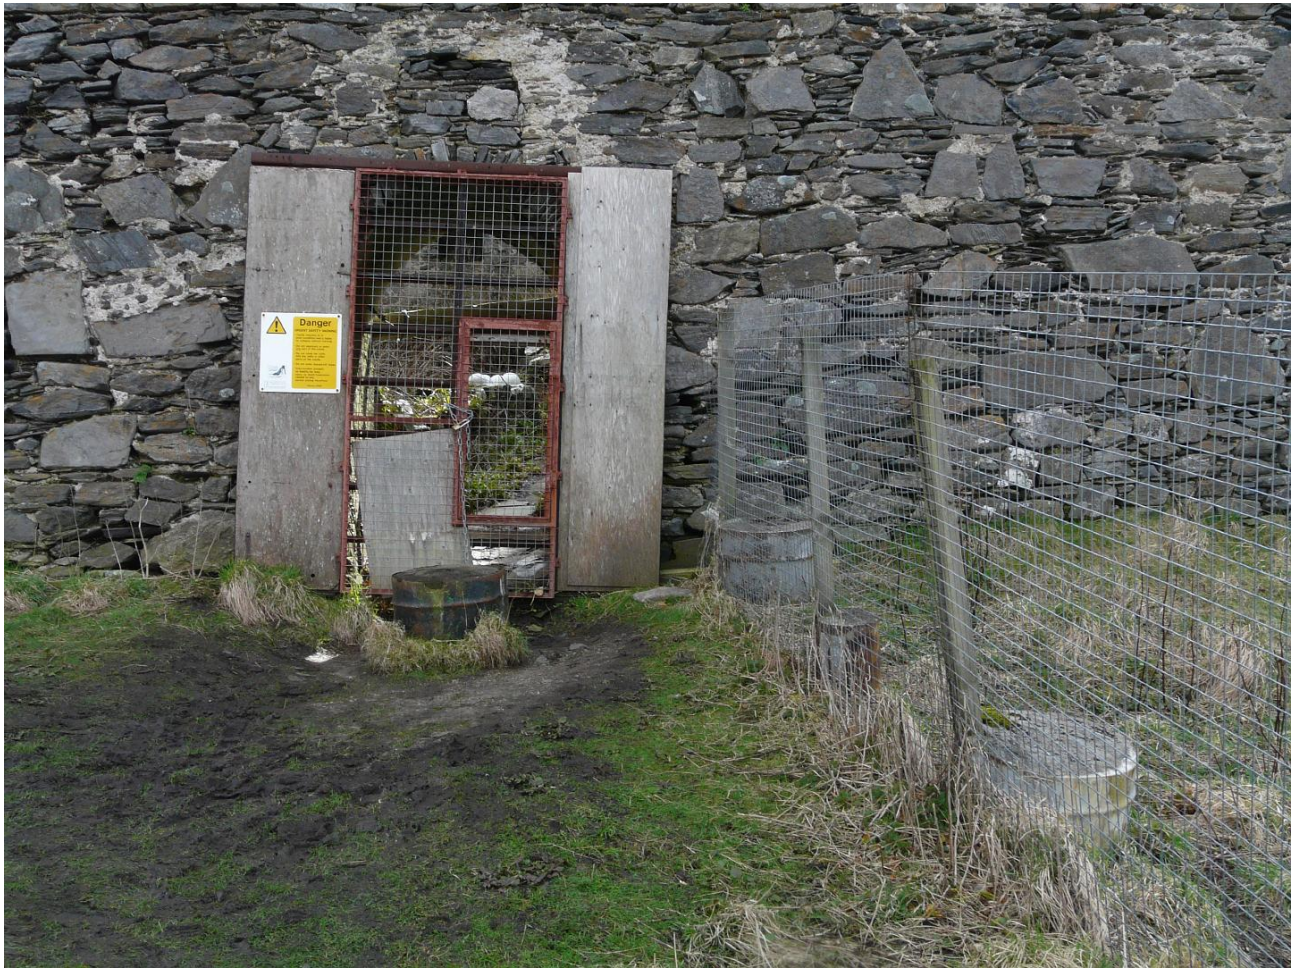
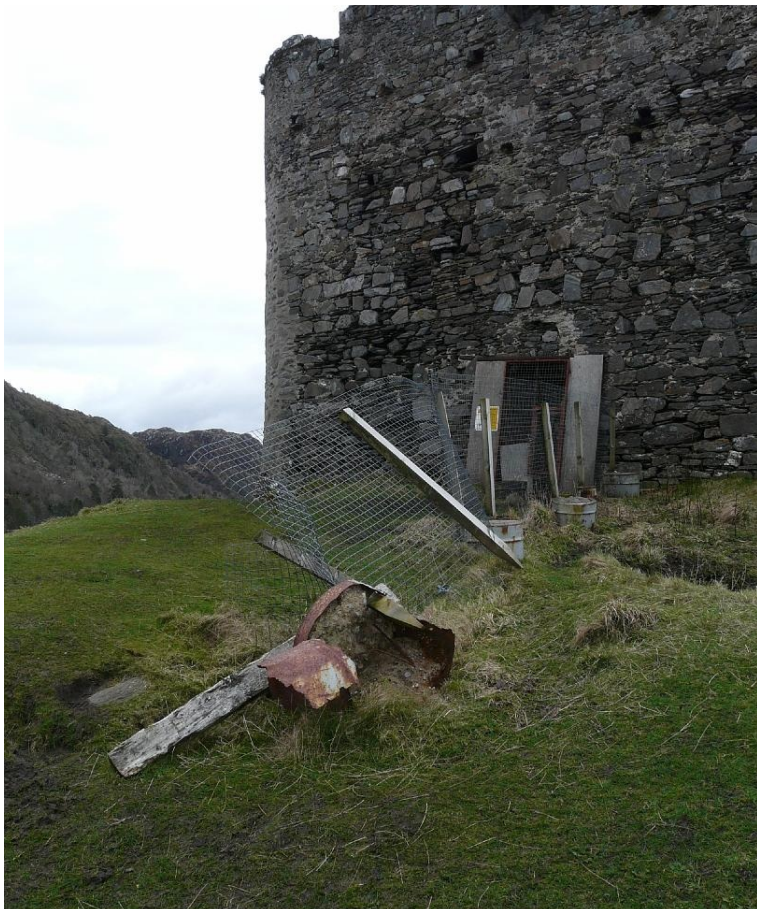
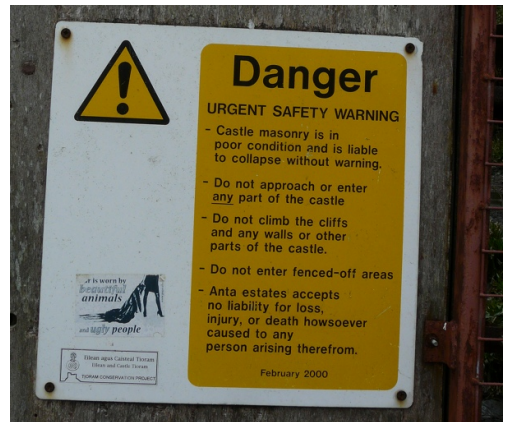
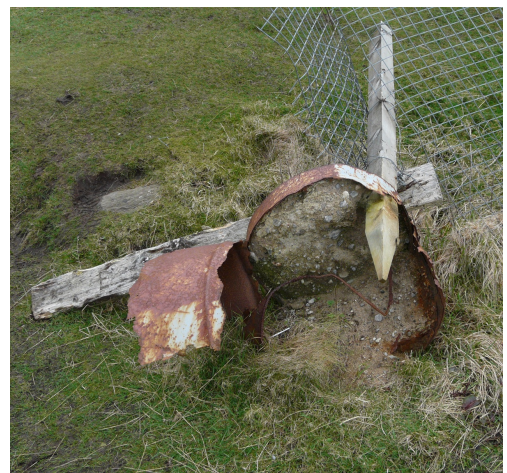
Entrance barricade, drum A and fence B

- A entrance: barricade with locked inset door and ‘Danger’ notice affixed; the drum in front once held a notice
- B wire fence supported by 7 posts mounted in drums (B1-7); B7 is broken with its contents mixed with the soil

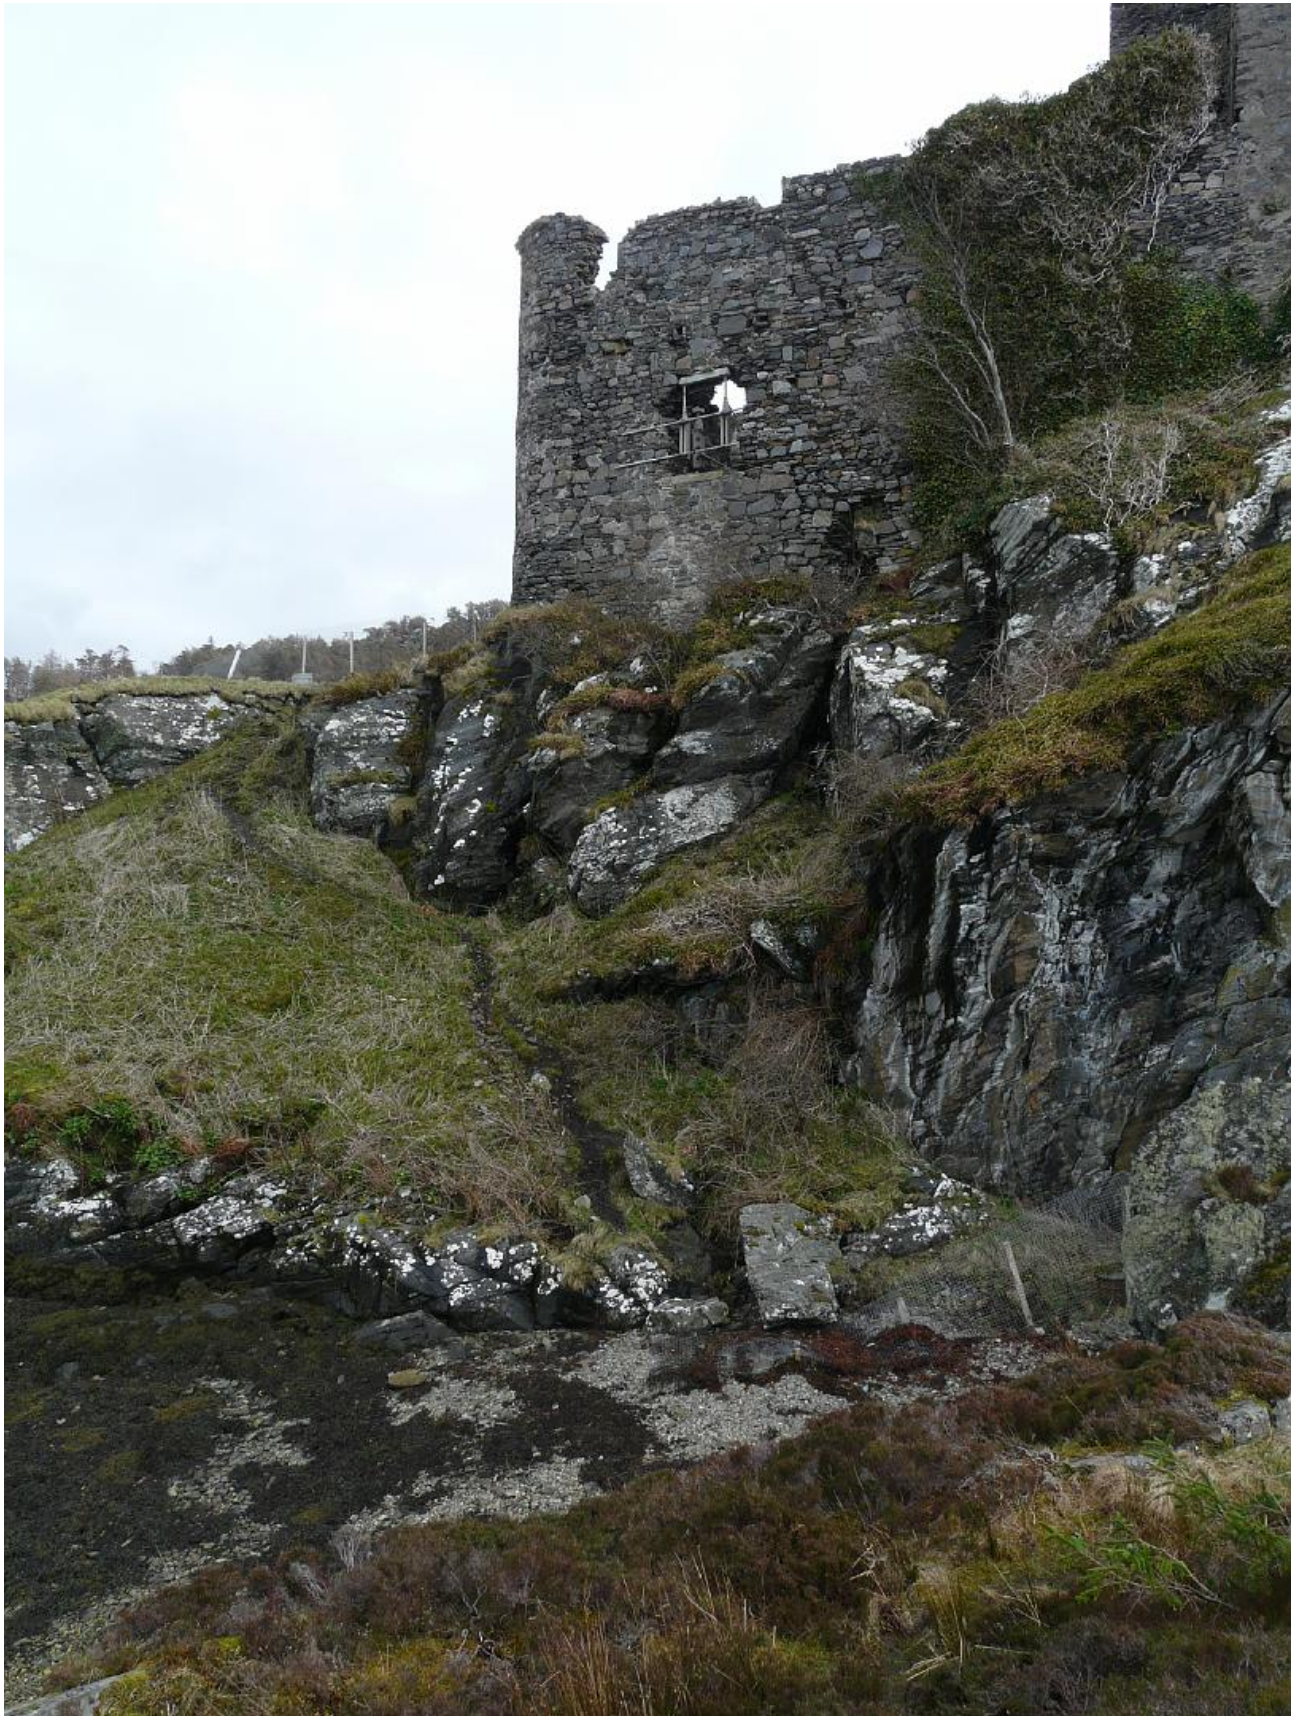
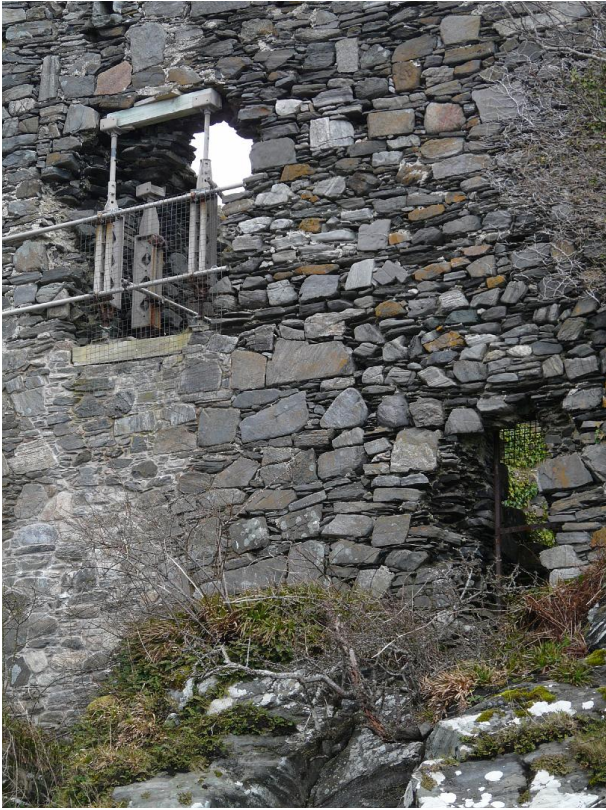
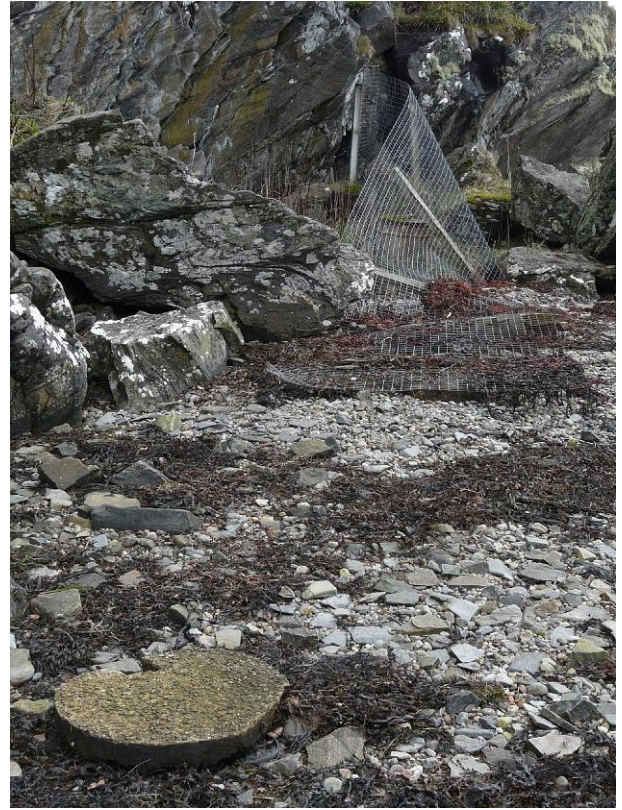
Openings in sea wall (C) above, fence D below

- C the two openings in the sea wall:
breach/window with only partially functioning scaffolding;
postern with tatty mesh barricade
- D fence with 6 (possibly 7?) drums supporting posts; drums in poor condition, ranging from D1-2 still holding together to only traces of D5-6

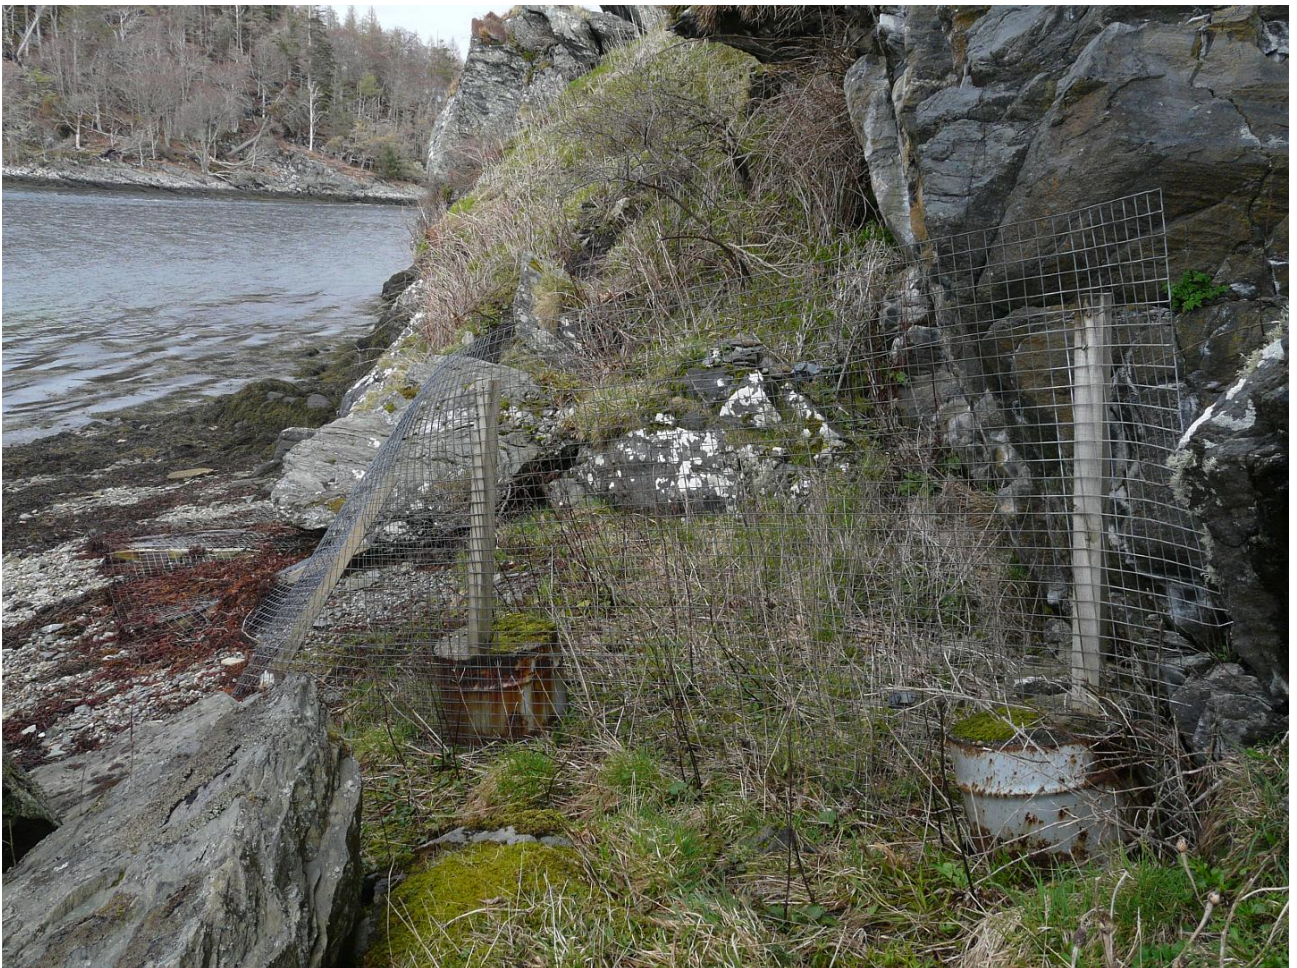
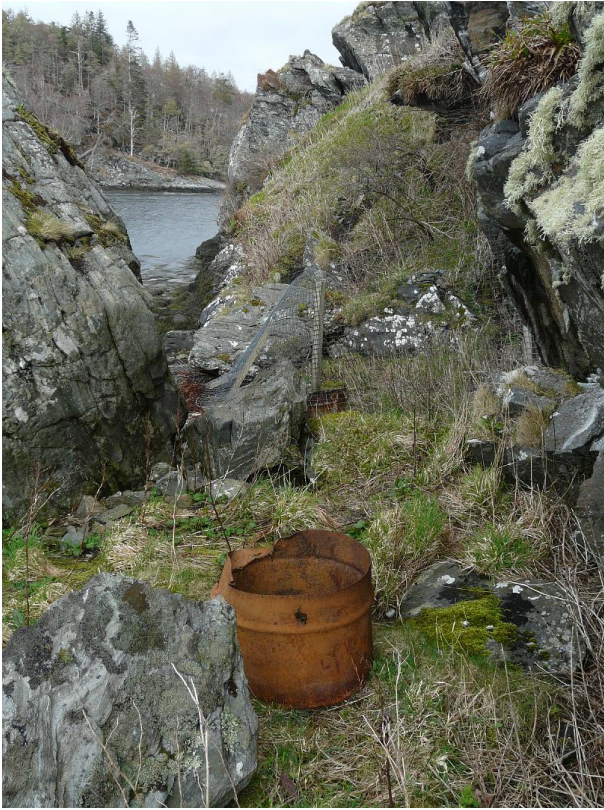
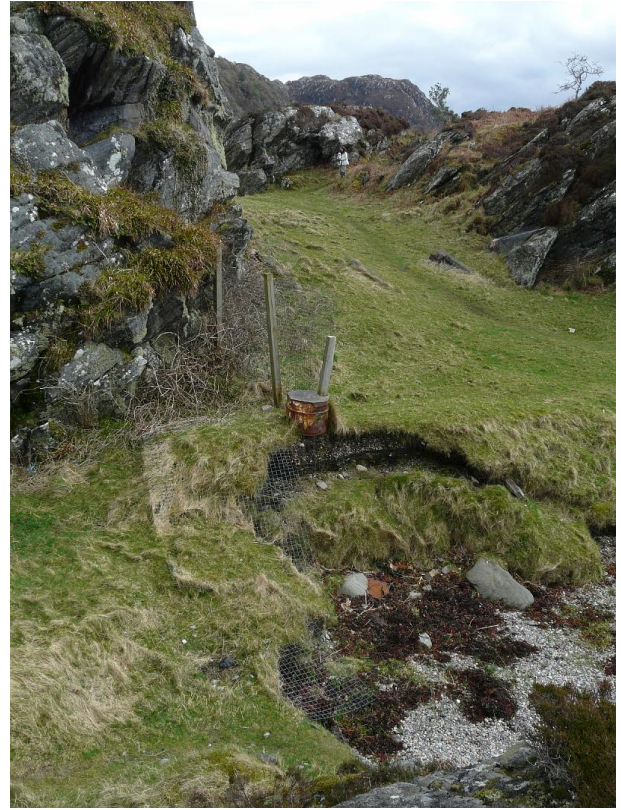
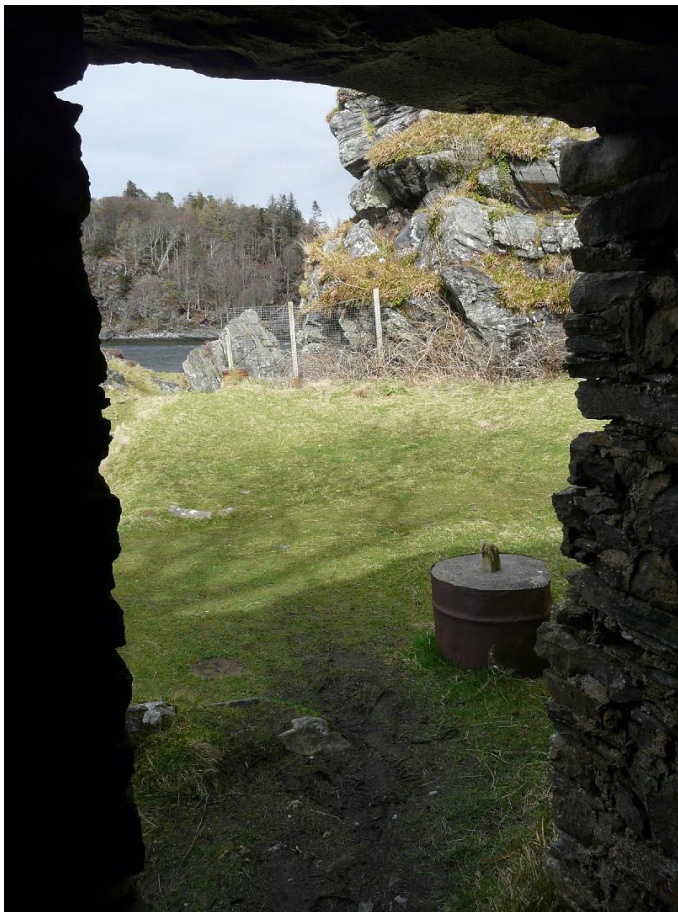
- E isolated empty drum, probably originally held a notice (but could be one displaced from one of the fence lines)
- F fence with 5 (or 6?) drums: F3 intact, and perhaps F1; of others only traces. end fencing now over-grown by turf

- G drum outside bathhouse - presumably once held a notice
- H fence with 5 drums: all collapsing or integrated with soil; fence largely submerged in turf

- drum E and fence D
- looking south to fence F with fence H in the middle distance
- drum G with fence F in the middle distance

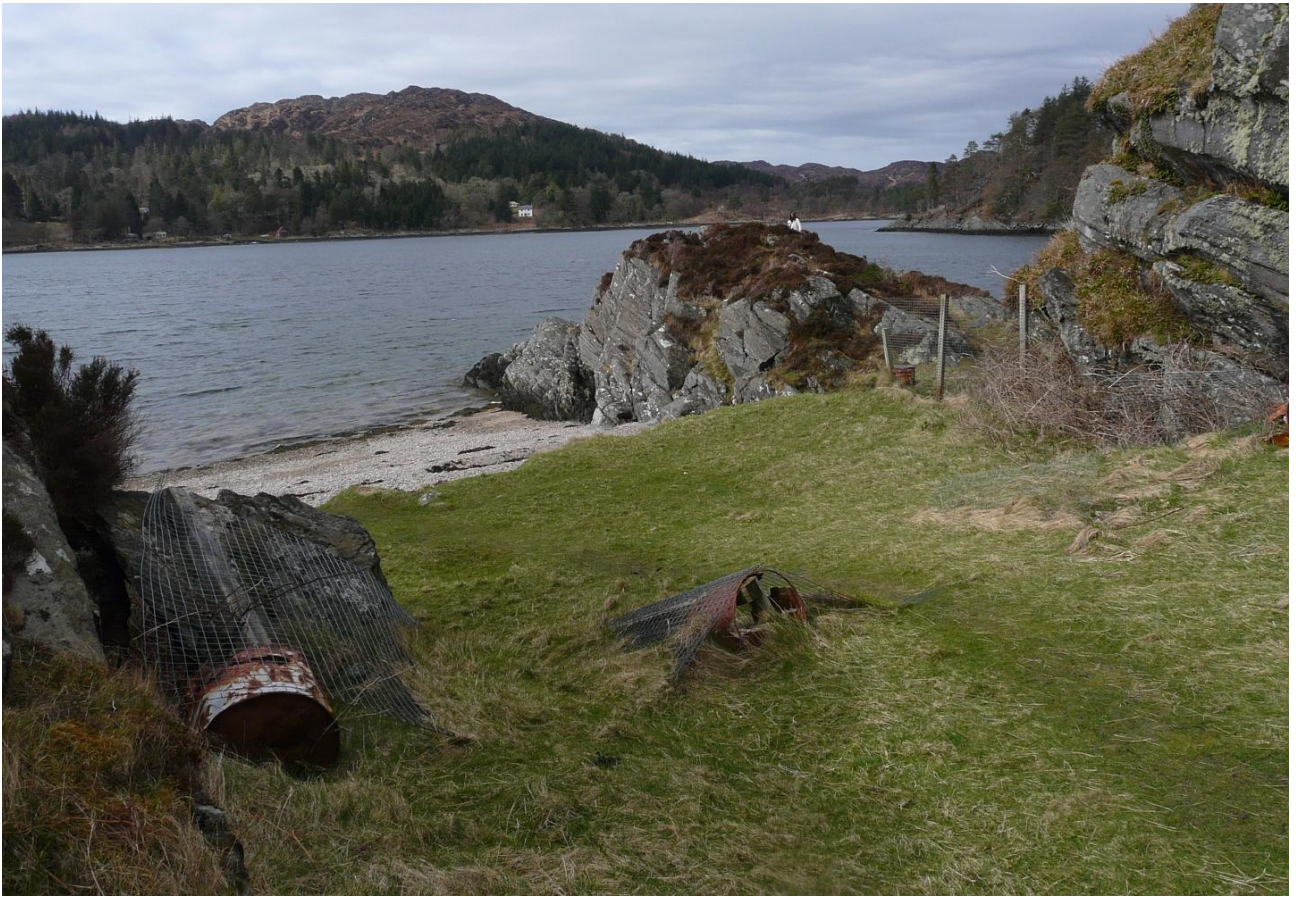
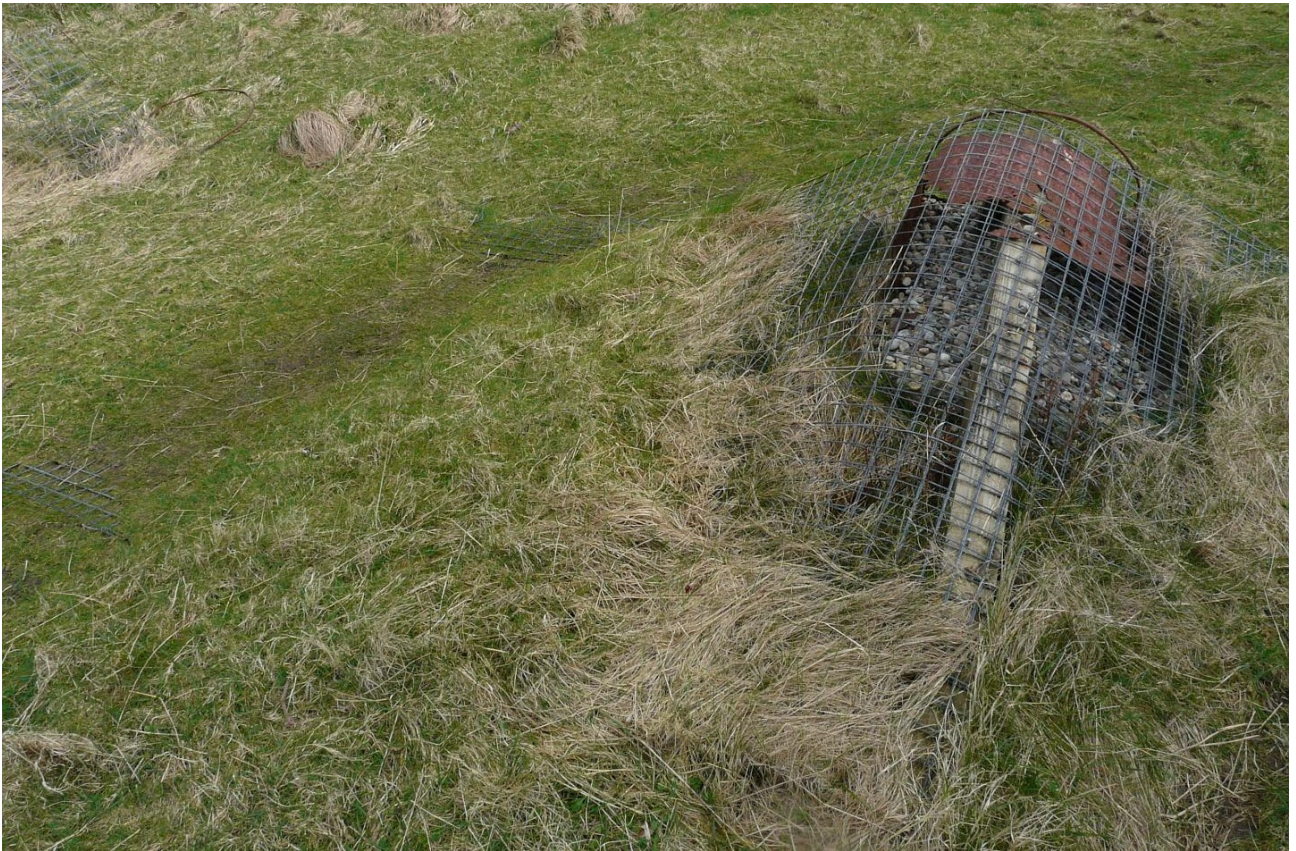
- looking north to fences H and F
- fence-post drum H2: note how much of fence is buried under turf

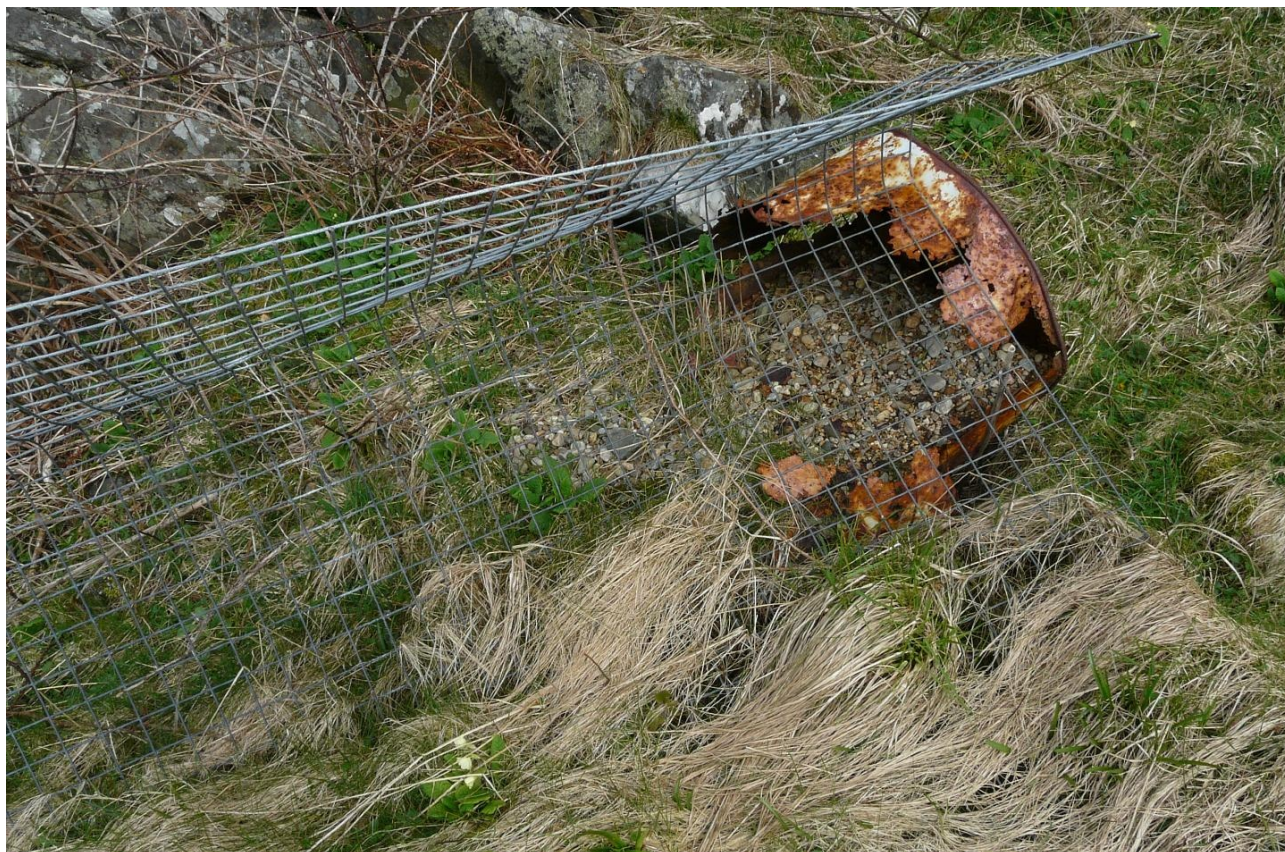
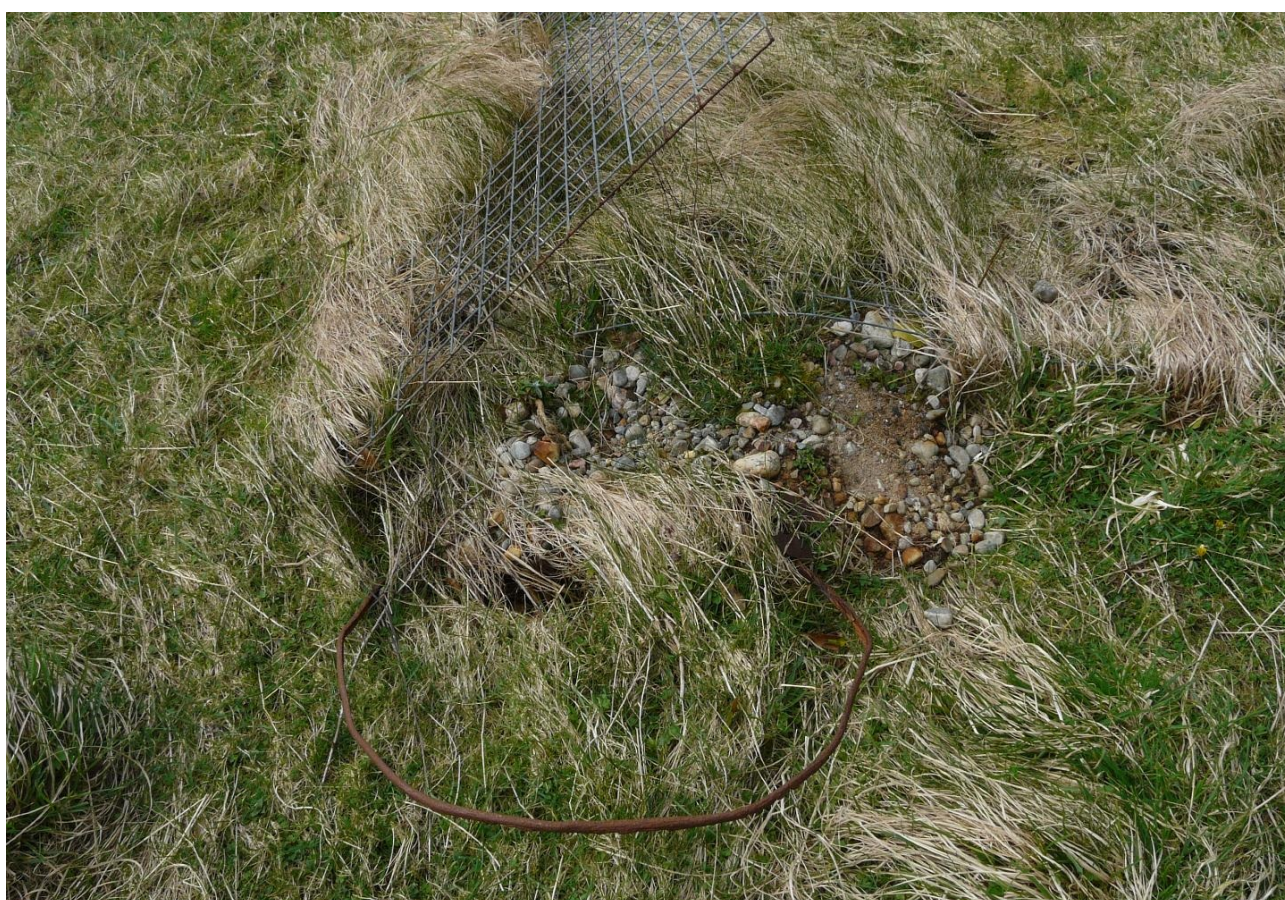
Two drums (H5 and H4) decaying into the soil

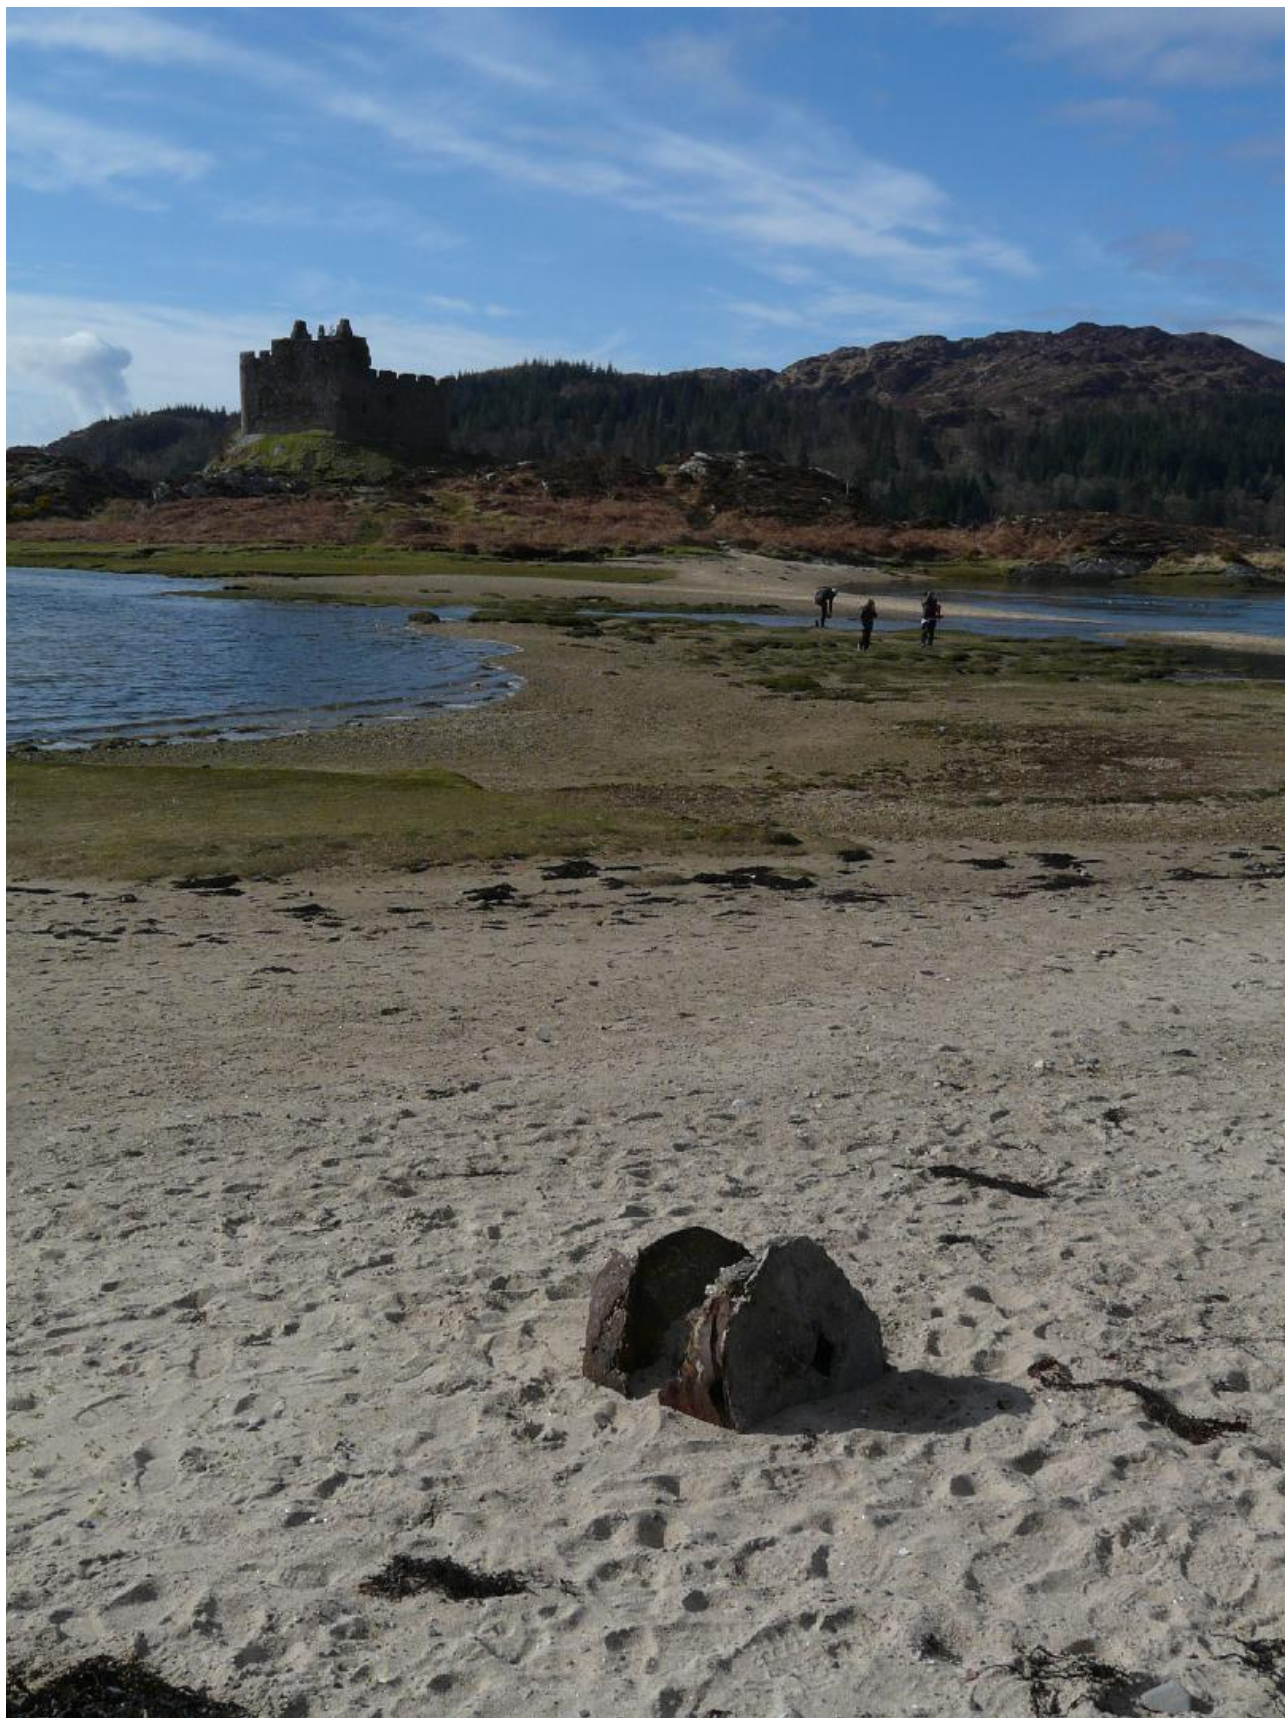
- I isolated drum that formerly held a notice
- J - not seen or photographed in April 2016 - drum for notice at edge of island nearest mainland
- K drum for notice, decaying into beach on mainland side of crossing

Drum K - on Dorlin beach
