CAISTAEL TIORAM - UPDATE

CONDITION 23rd JULY 2014

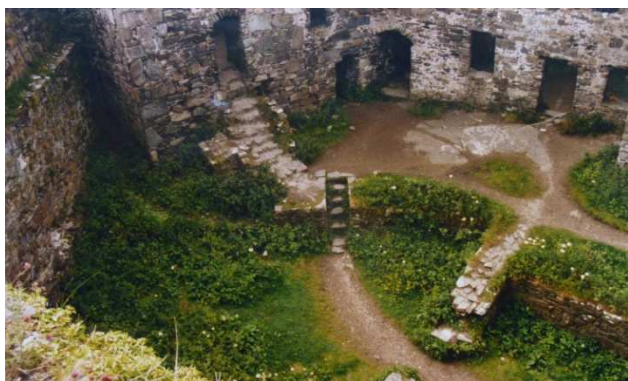
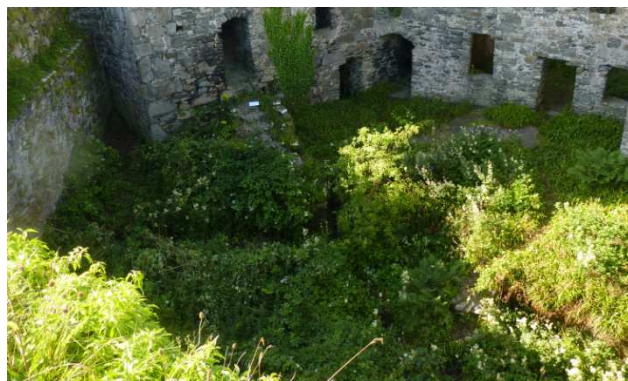
By reference to detailed photographs taken in 1997 (when the castle was put up for sale) it has been possible to see how little loss or damage to masonry there has been. There are no more stones lying on the ground today than there were 17 years ago. The main change has been a considerable increase in vegetation, in the courtyard and on the wallheads.

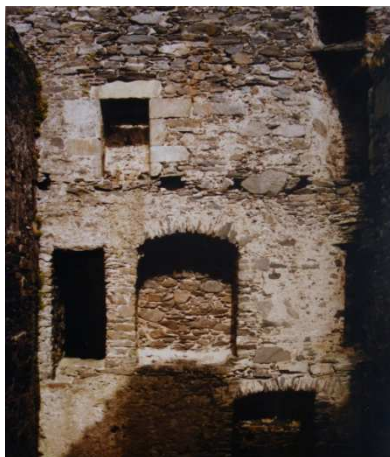
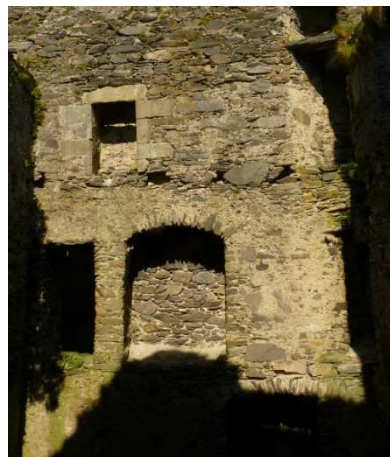
Rowan tree growing on the wallhead of SW Range, showing almost no change since 1997.
